COMPOSITE JOIST PROJECT

SPONSORED BY STEEL JOIST INSTITUTE

INTERPRETATION OF COMPOSITE JOIST TEST RESULTS

September 1967

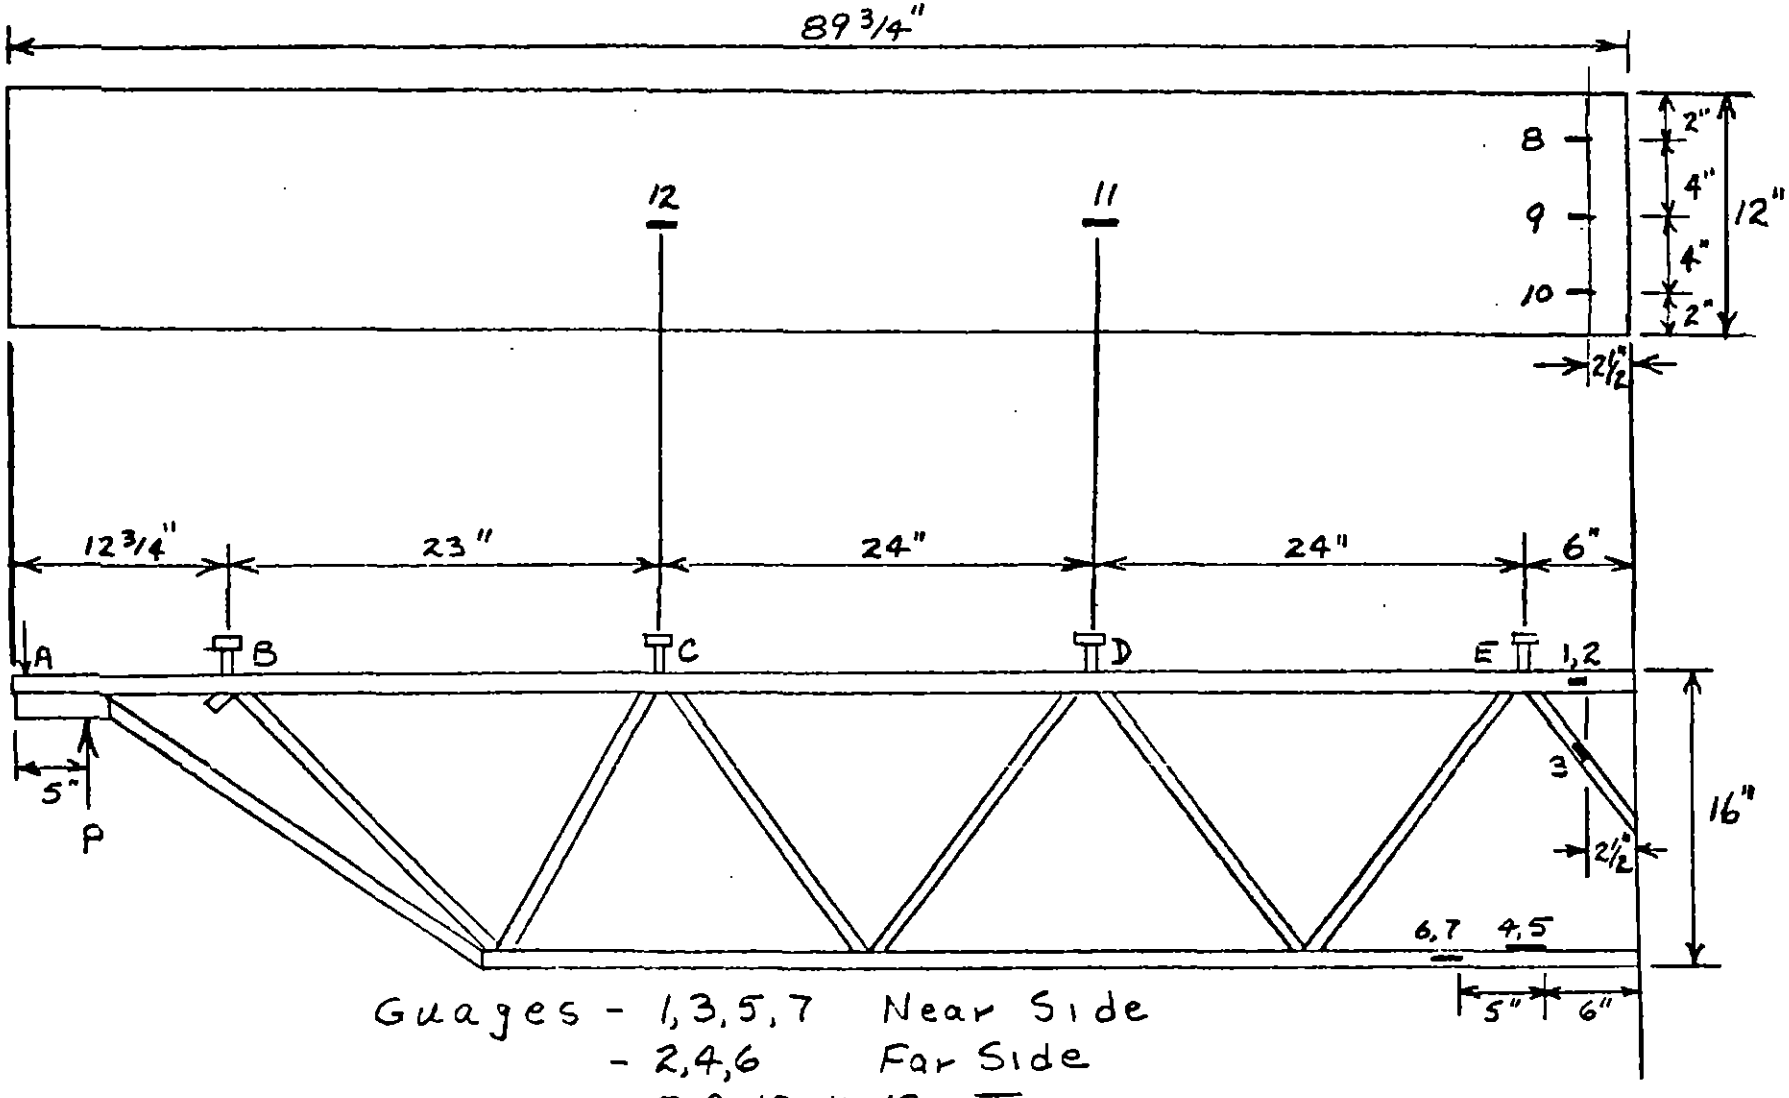
FIG 3a Test Joist C1a

4.1.1 C1a - After several load increments separation was noticed between the concrete and the compression chord at the last shear connector. Then a tension crack developed at the last shear connector and eventually extended nearly to the top of the slab. As the maximum load was obtained a load report was heard, which later inspection revealed was caused by the failure of the first three shear connectors. The loading was continued until the compression chord buckled.

The failure was attributed to yielding of the tension chord, followed by the failure of three of the shear connectors and then the buckling of the compression chord.

C1a - yielding of tension chord, fracture of three shear connectors, buckling of compression chord.

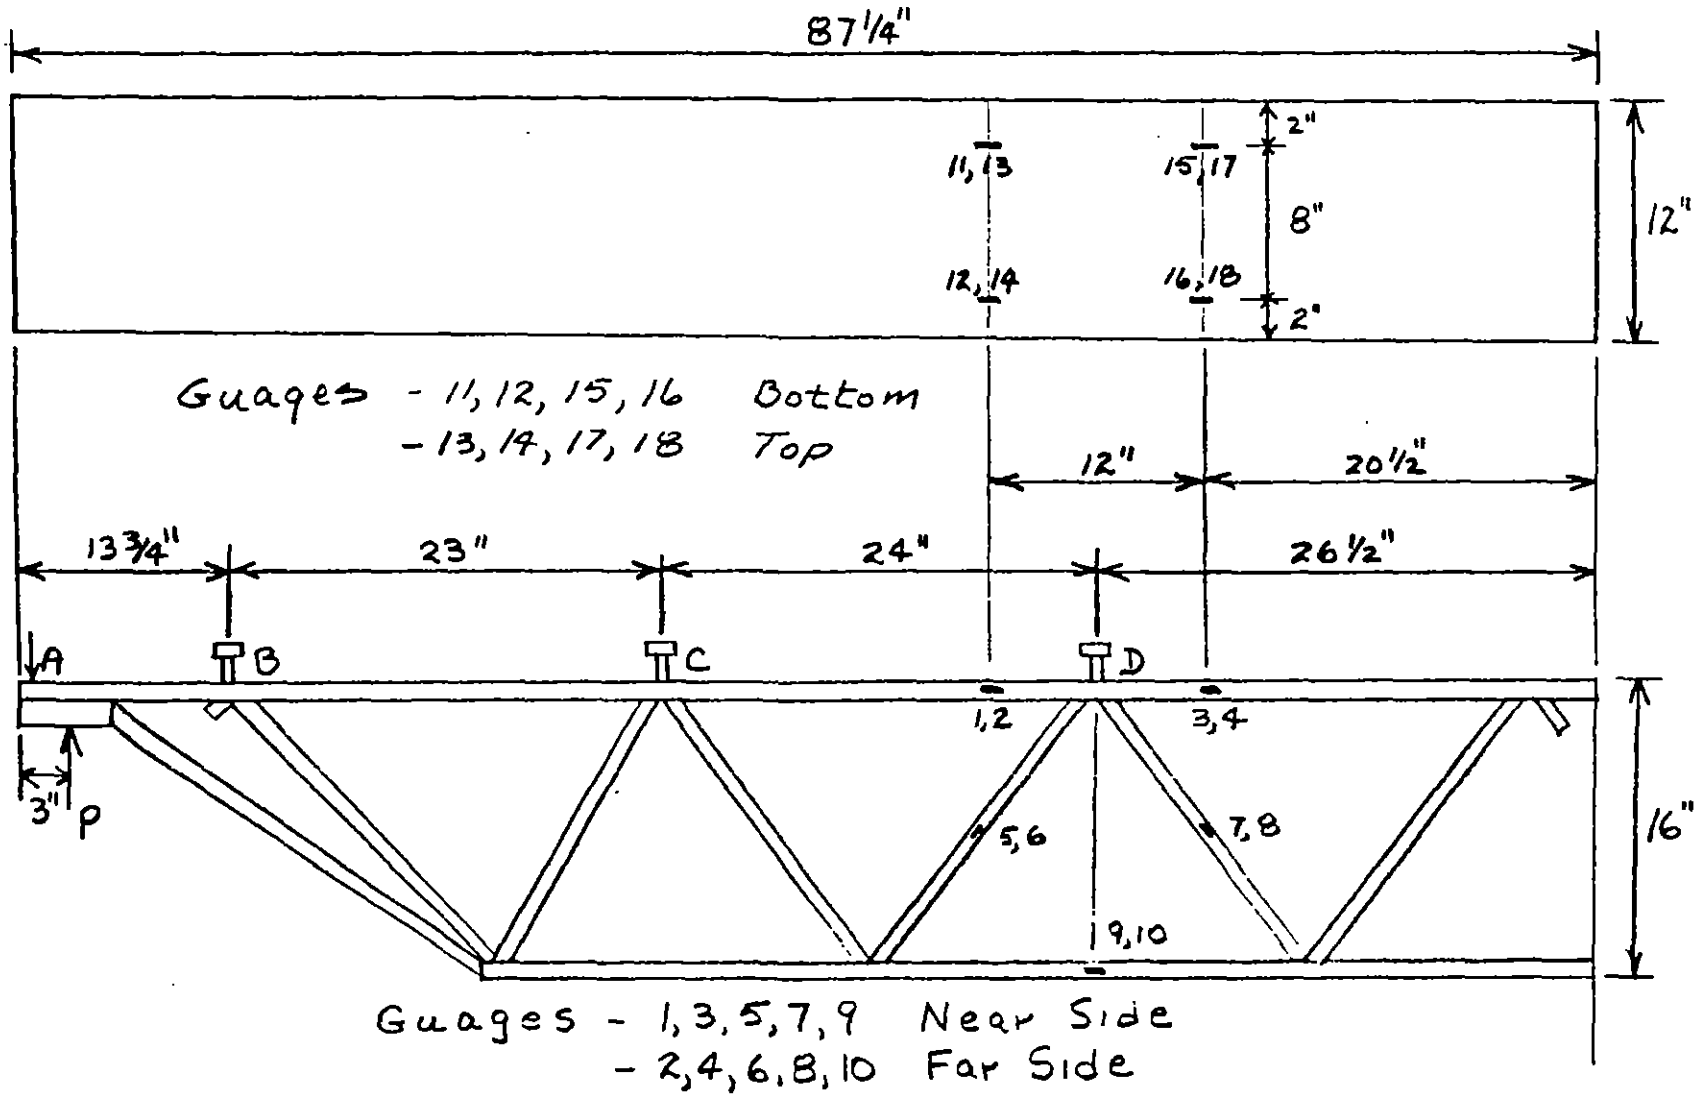
FIG 3b Test Joist C1b

4.1.2 C1b - The load was applied to the cantilever in increments until a weld failed. The load was removed, the weld was repaired since no damage was done before the failure occurred.

The first cracks between the slab and compression chord were noticed as the load approached that making the tension chord yield. The next load increments resulted in the yielding of the tension chord and considerable separation of the slab and compression chord at the last shear connection. The compression chord at the last shear connector began to buckle, a loud report occurred, indicating the failure of the shear connectors.

The failure occurred due to the yielding of the tension chord, the buckling of the compression chord and then the failure of the shear connectors.

C1b - yielding of tension chord, buckling of compression chord, fracture of the shear connectors.

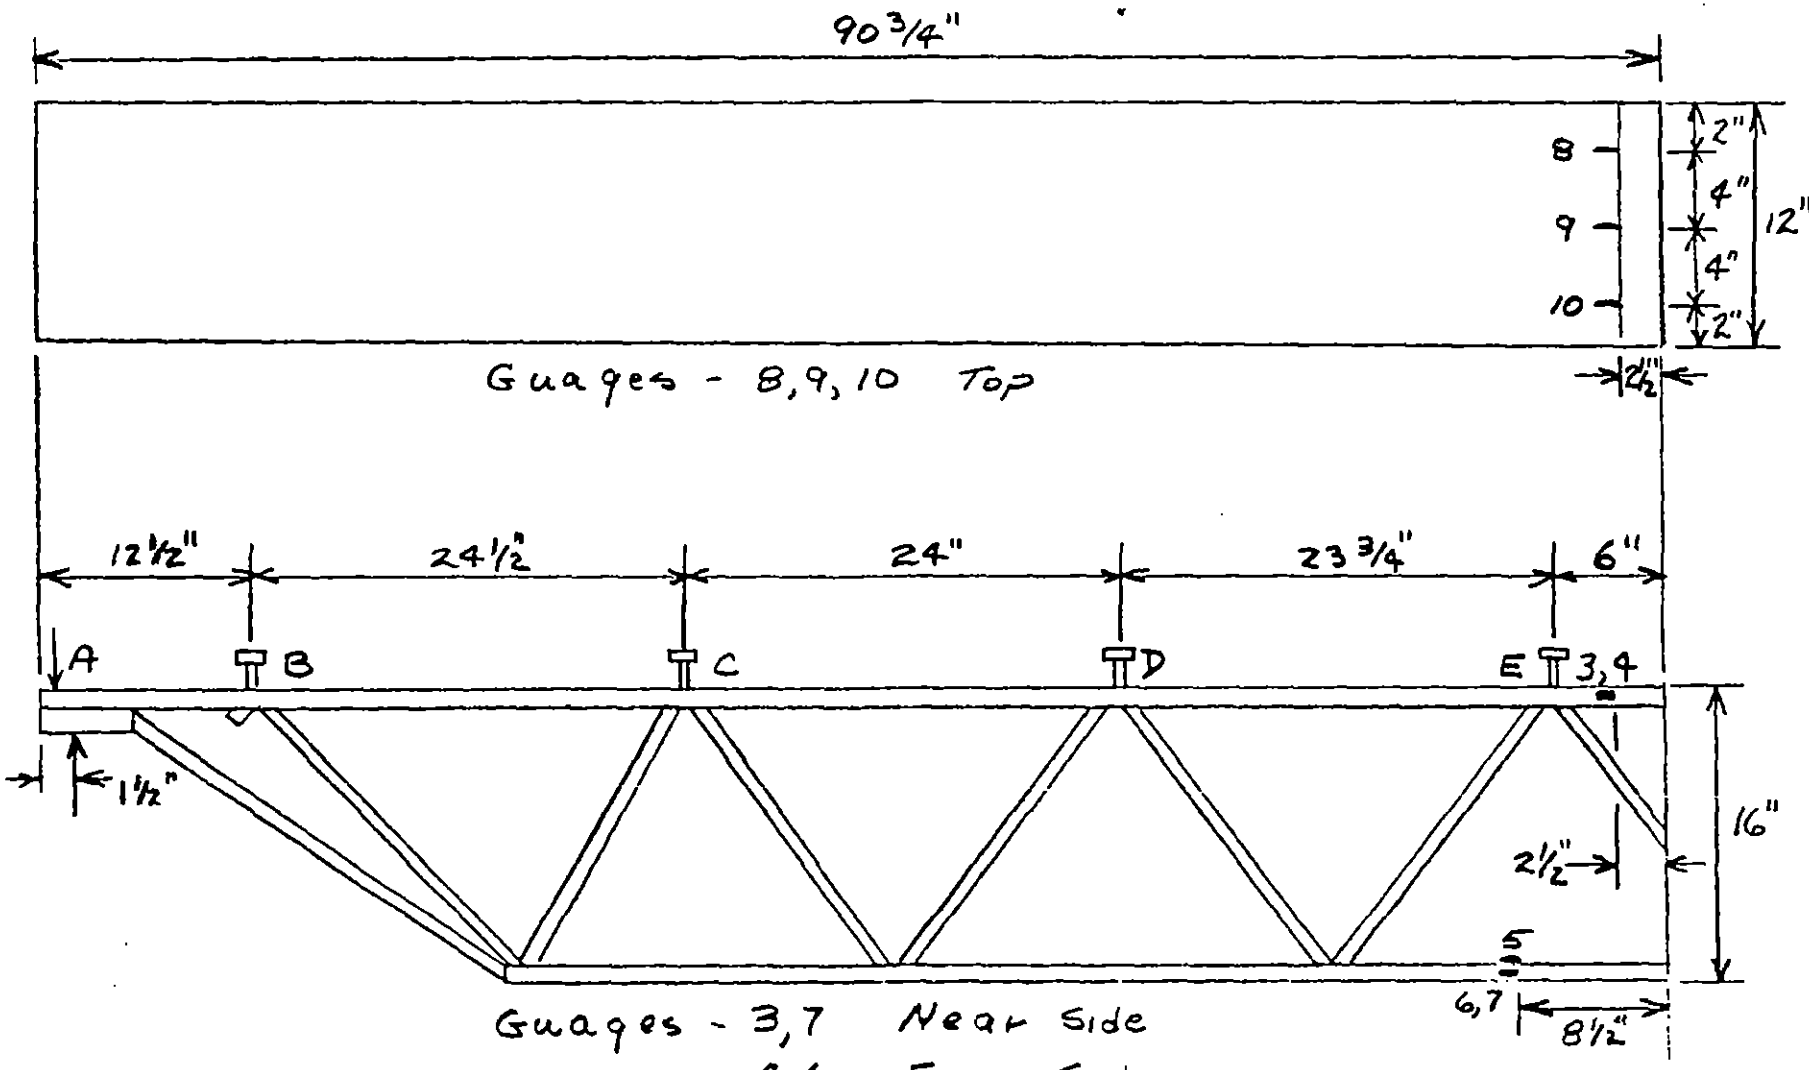
Fig. 3c Test Joist C4

4.1.3 _C4 - With only a couple of load increments applied the slab at the first shear connector cracked nearly to the top due to the large rotation. As the next load increments were applied a separation occurred between the compression chord and the slab from the first to third shear connectors. With the next load increment the tension chord failed where it was welded to the connecting bolt.

The failure was due to the untimely failure of the tension chord connection.

C4 - failure of the tension chord connection.

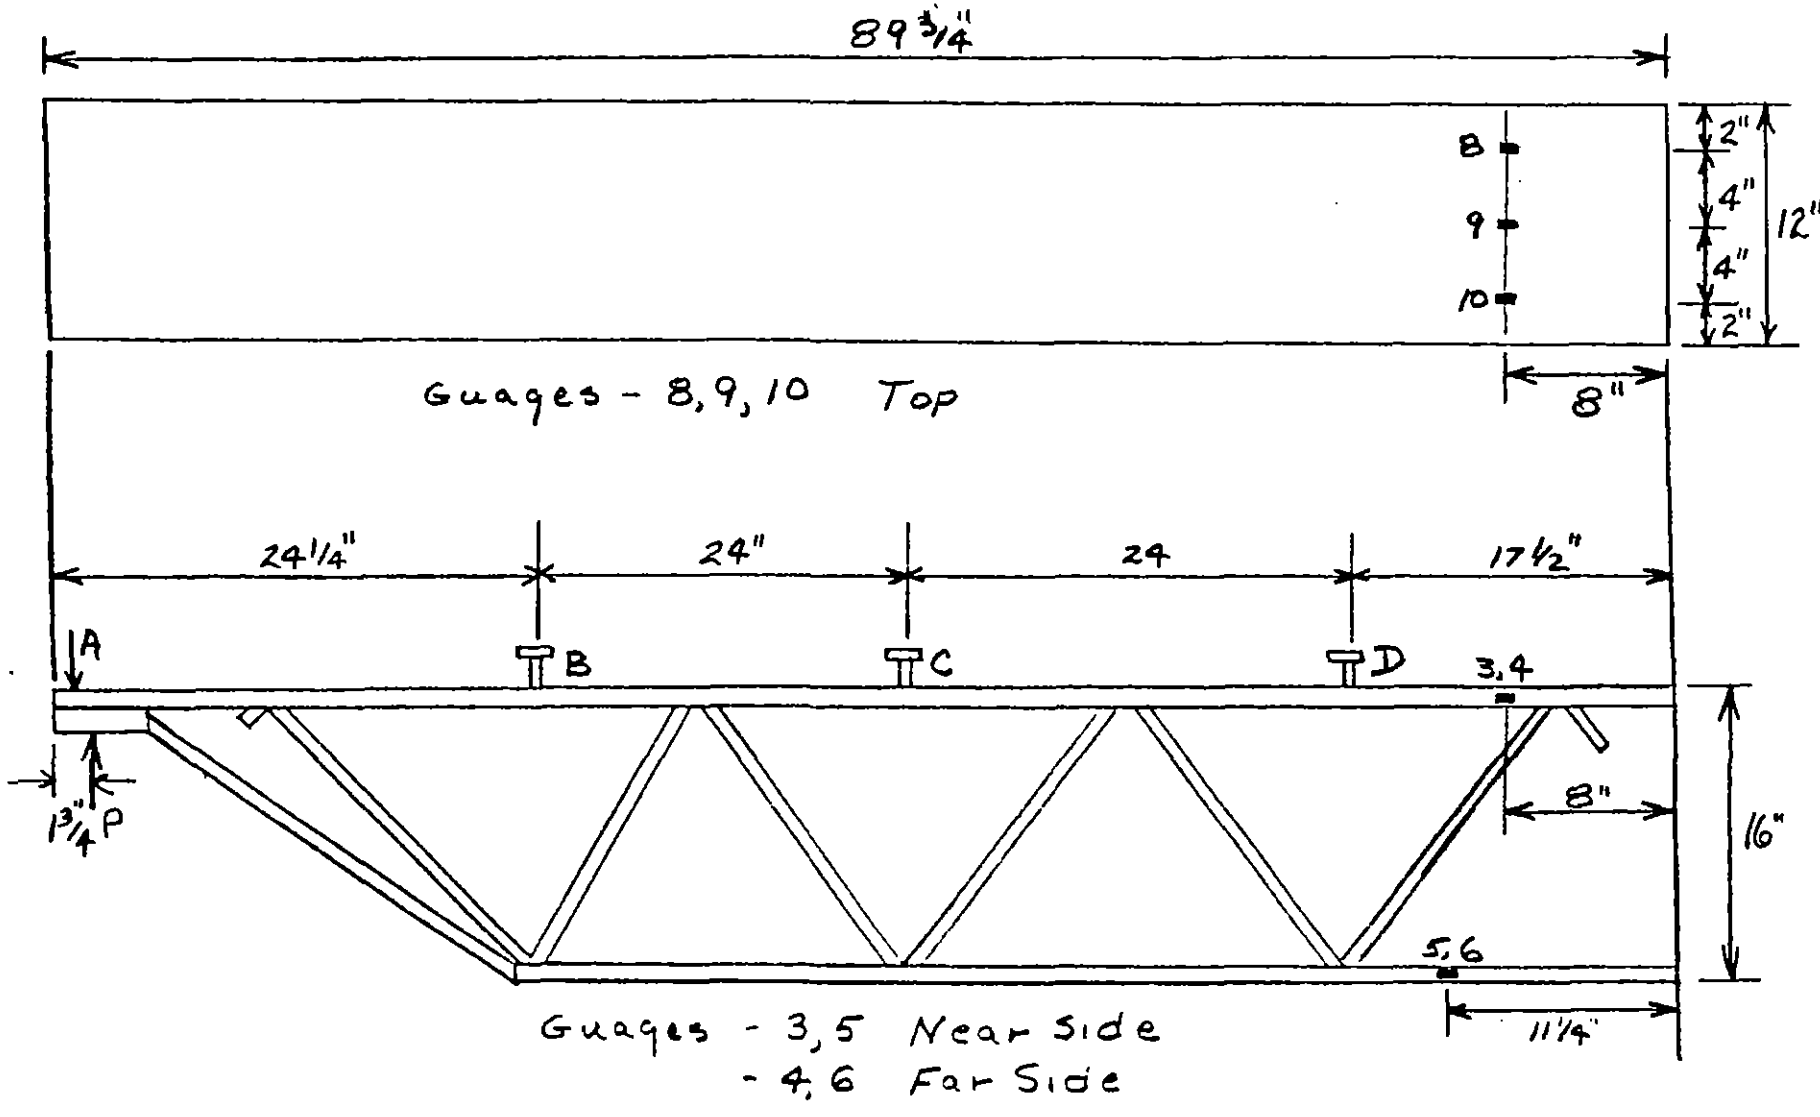
FIG. 3d Test Joist C7

4.1.4 _C7 - The load was applied and increased until the tension chord yielded at which time the slab at the last shear connector cracked to mid-depth. As the load was increased beyond this point a loud report was heard. Later inspection revealed that the first and second shear connectors had failed. More load was applied until the compression chord buckled.

The failure was attributed to the yielding of the tension chord, followed by the fracture of the two shear connectors and then the buckling of the compression chord.

C7 - yielding of tension chord, fracture of two shear connectors, buckling of compression chord.

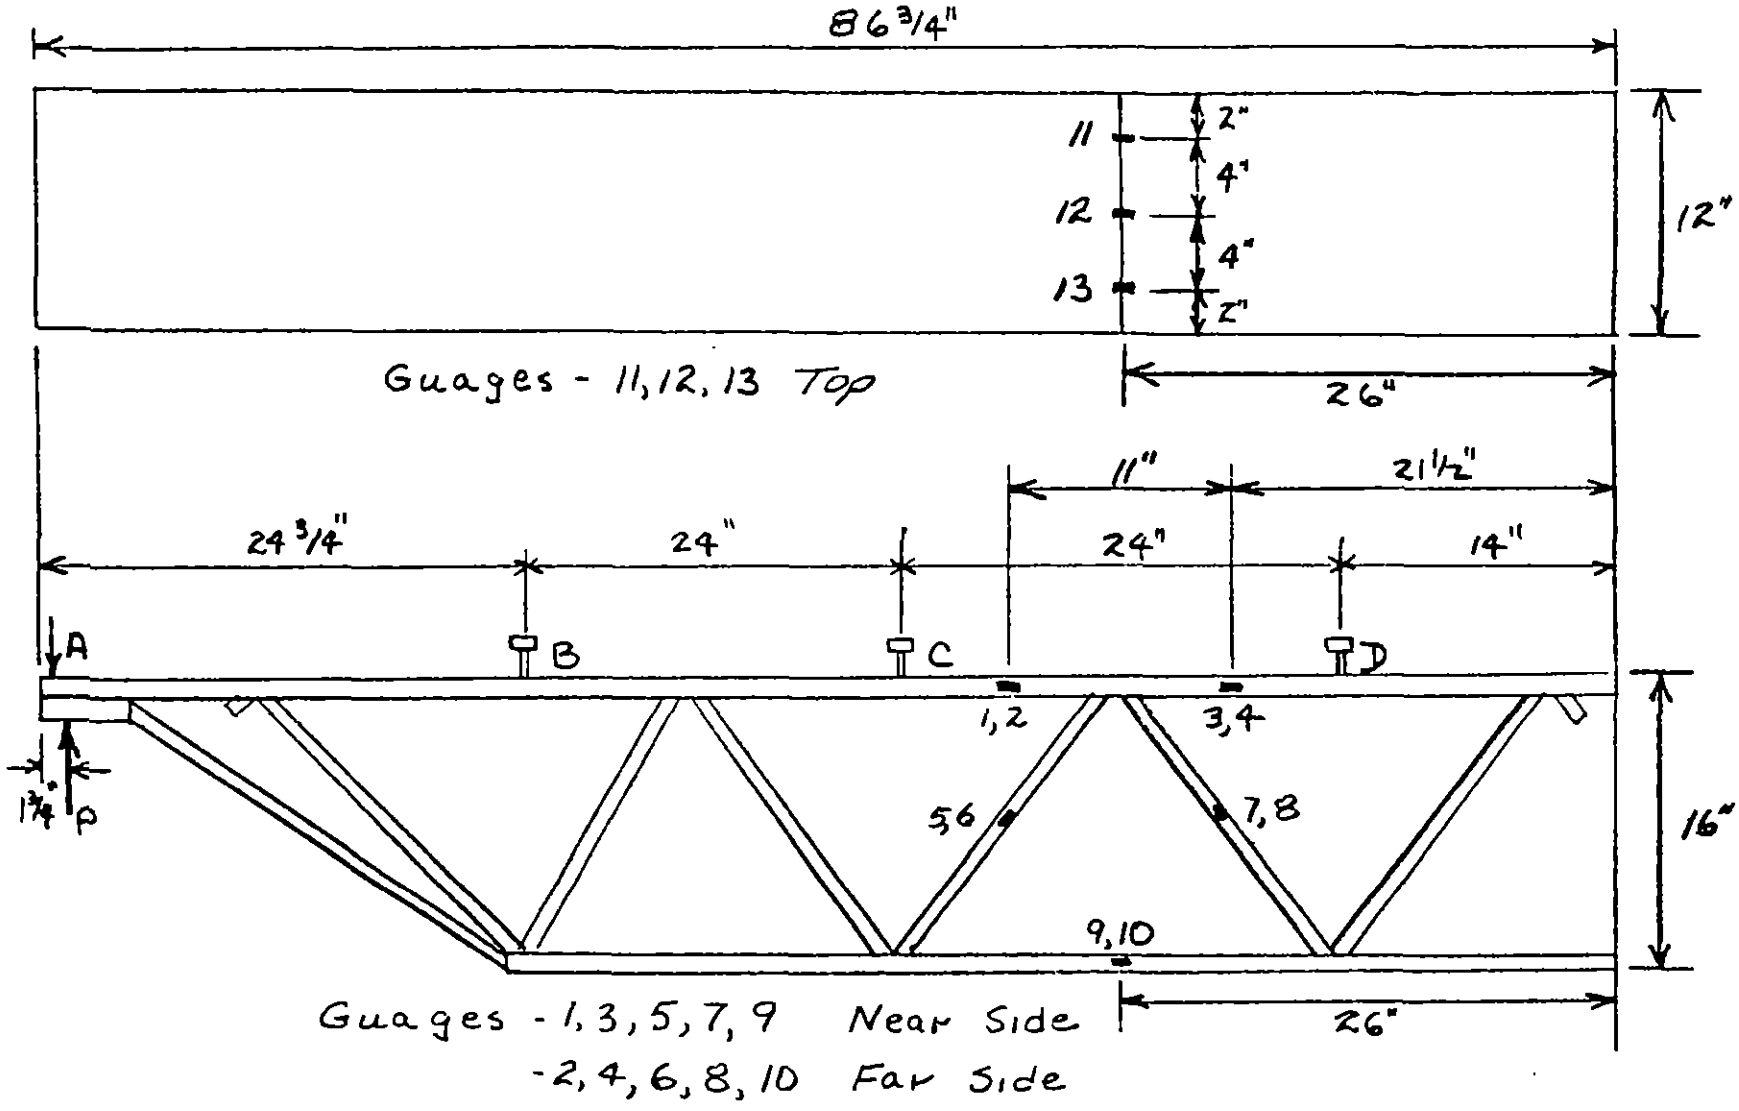
FIG 3e Test Joist C8a

4.1.5 _C8a - After the load had reached near the value causing yielding in the tension chord a crack at the first shear connector had developed a considerable way into the slab. The tension chord connection then failed. The load was removed, the tension connection was then repaired.

The load was applied until again near the yield point of the tension chord. A tension crack in the slab developed at the third shear connector. The application of load was continued until the tension chord again failed in the vicinity of the connection weld.

The failure was due to the fracture of the weld connection of the tension chord.

C8a - failure of the tension chord connection.

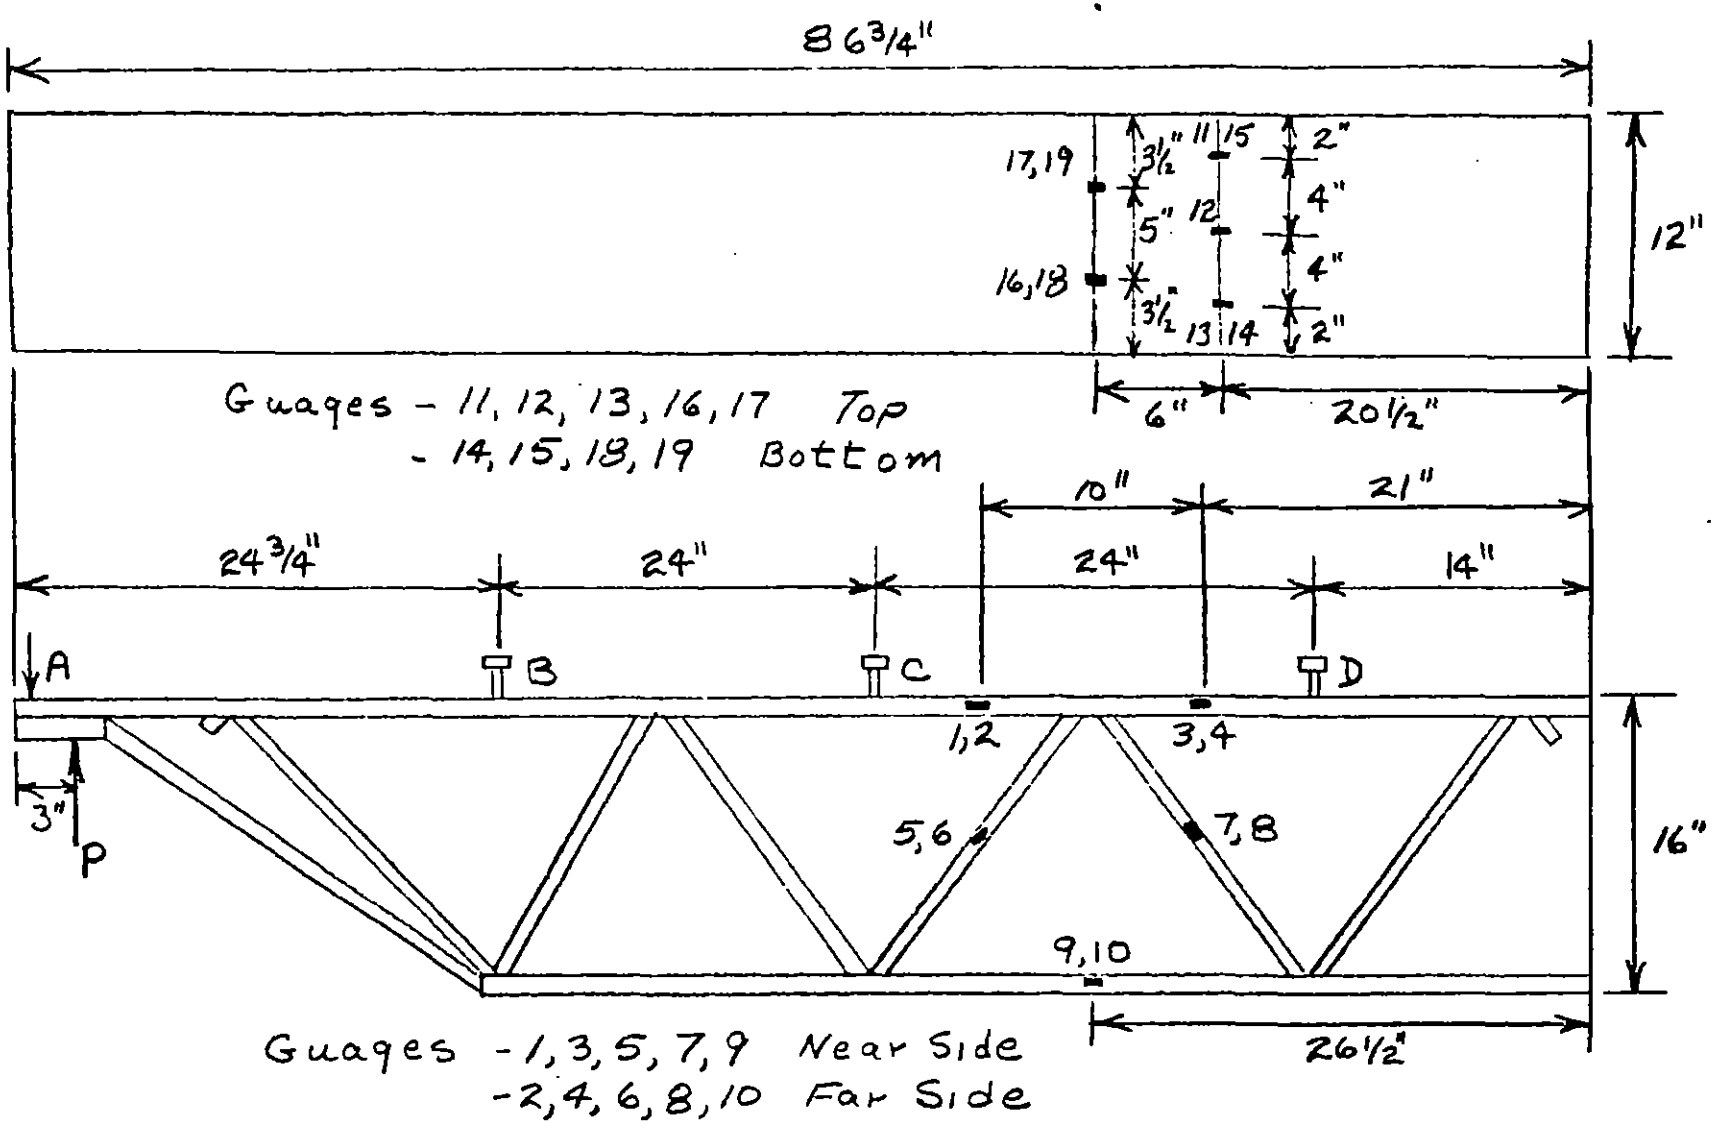
FIG 3f Test Joist C8b

4.1.6 C8b - The load was incremented for some time before the first tension crack was observed at the first shear connector. The load was increased until cracks also developed at the third shear connector. This maximum load was then held for some time while the deflection increased. Finally the tension connection failed.

The failure was a result of the fracture of the tension chord connection.

C8b - failure of the tension chord connection.

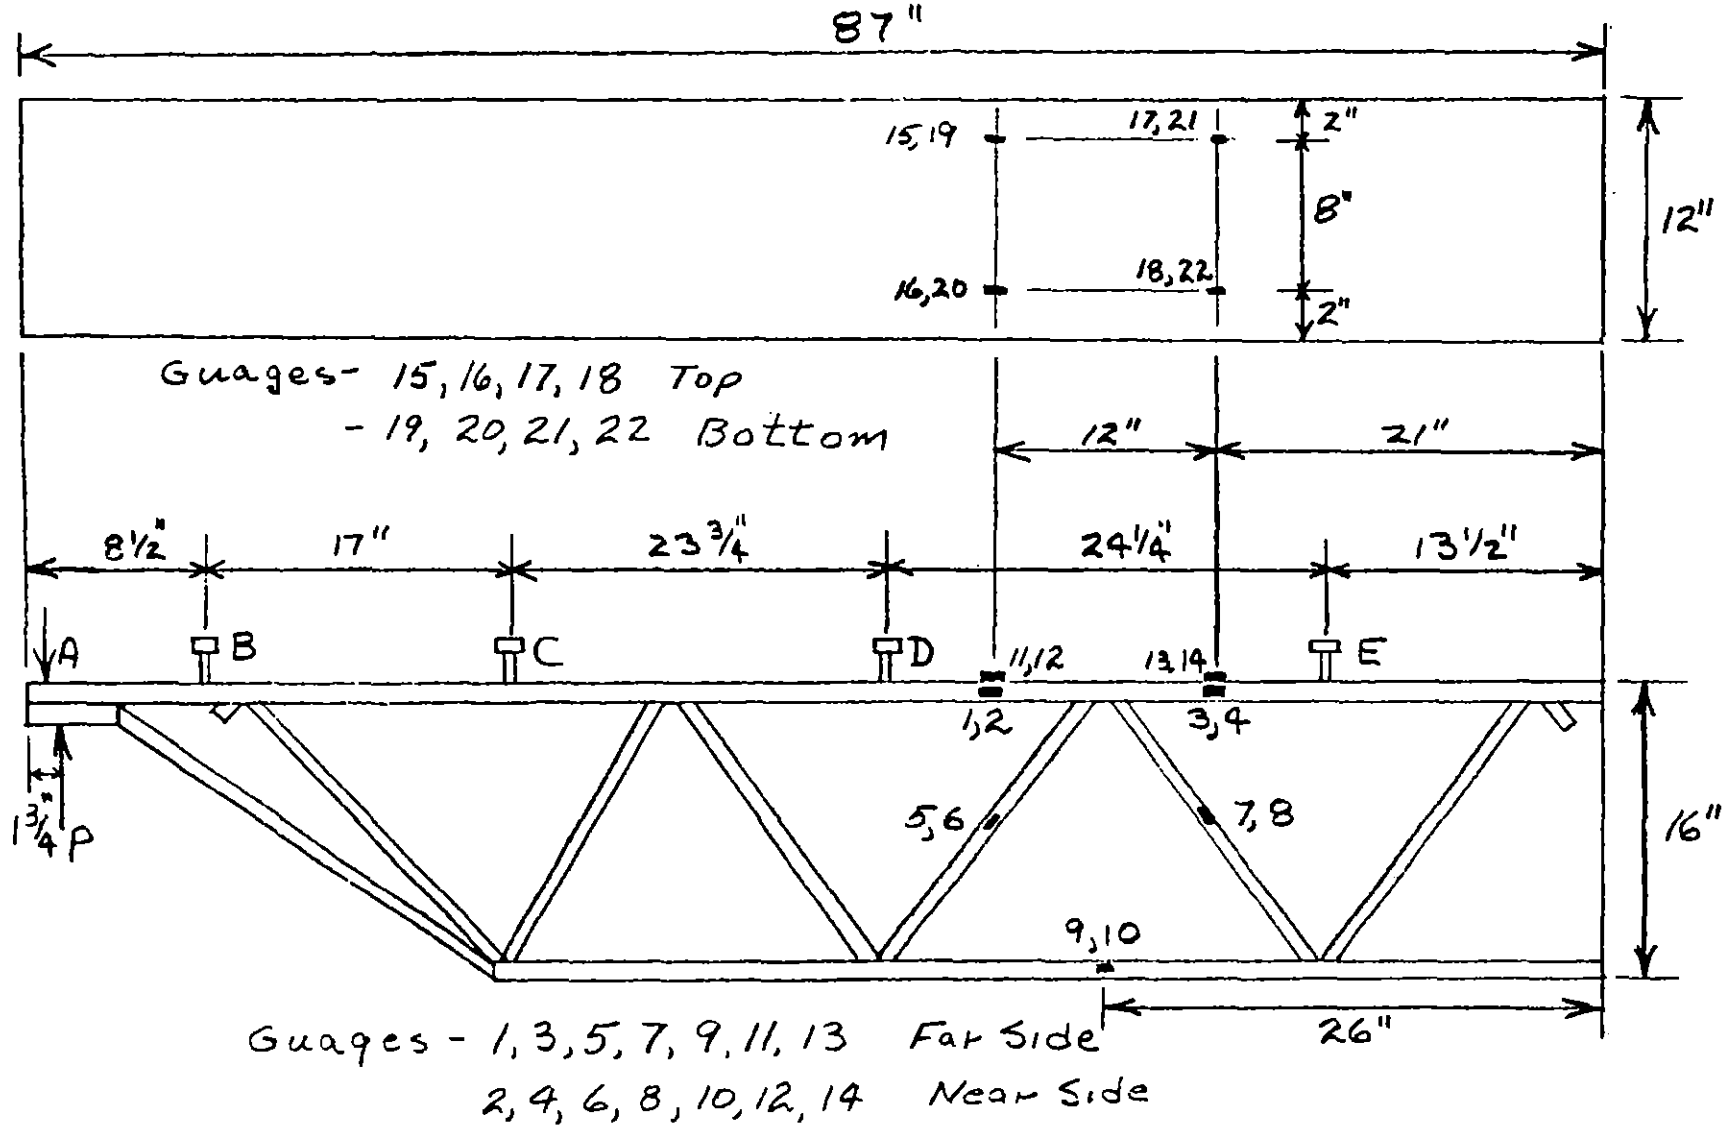
FIG 3g - Test Joist C9

4.1.7. C9 - After several load increments were applied a slight separation of the compression chord from the slab was noted. Additional loading resulted in the fracture of the tension chord. The load was removed and the tension chord was repaired.

The load was again applied until the stress in the tension chord was near the yield point at which time a load report was heard. Later investigation revealed that three of the four shear connectors had fractured. Additional load increments were applied until the compression chord buckled.

The failure was attributed to the fracture of the shear connectors followed by the buckling of the compression chord.

C9 - fracture of three shear connectors, buckling of the compression chord.

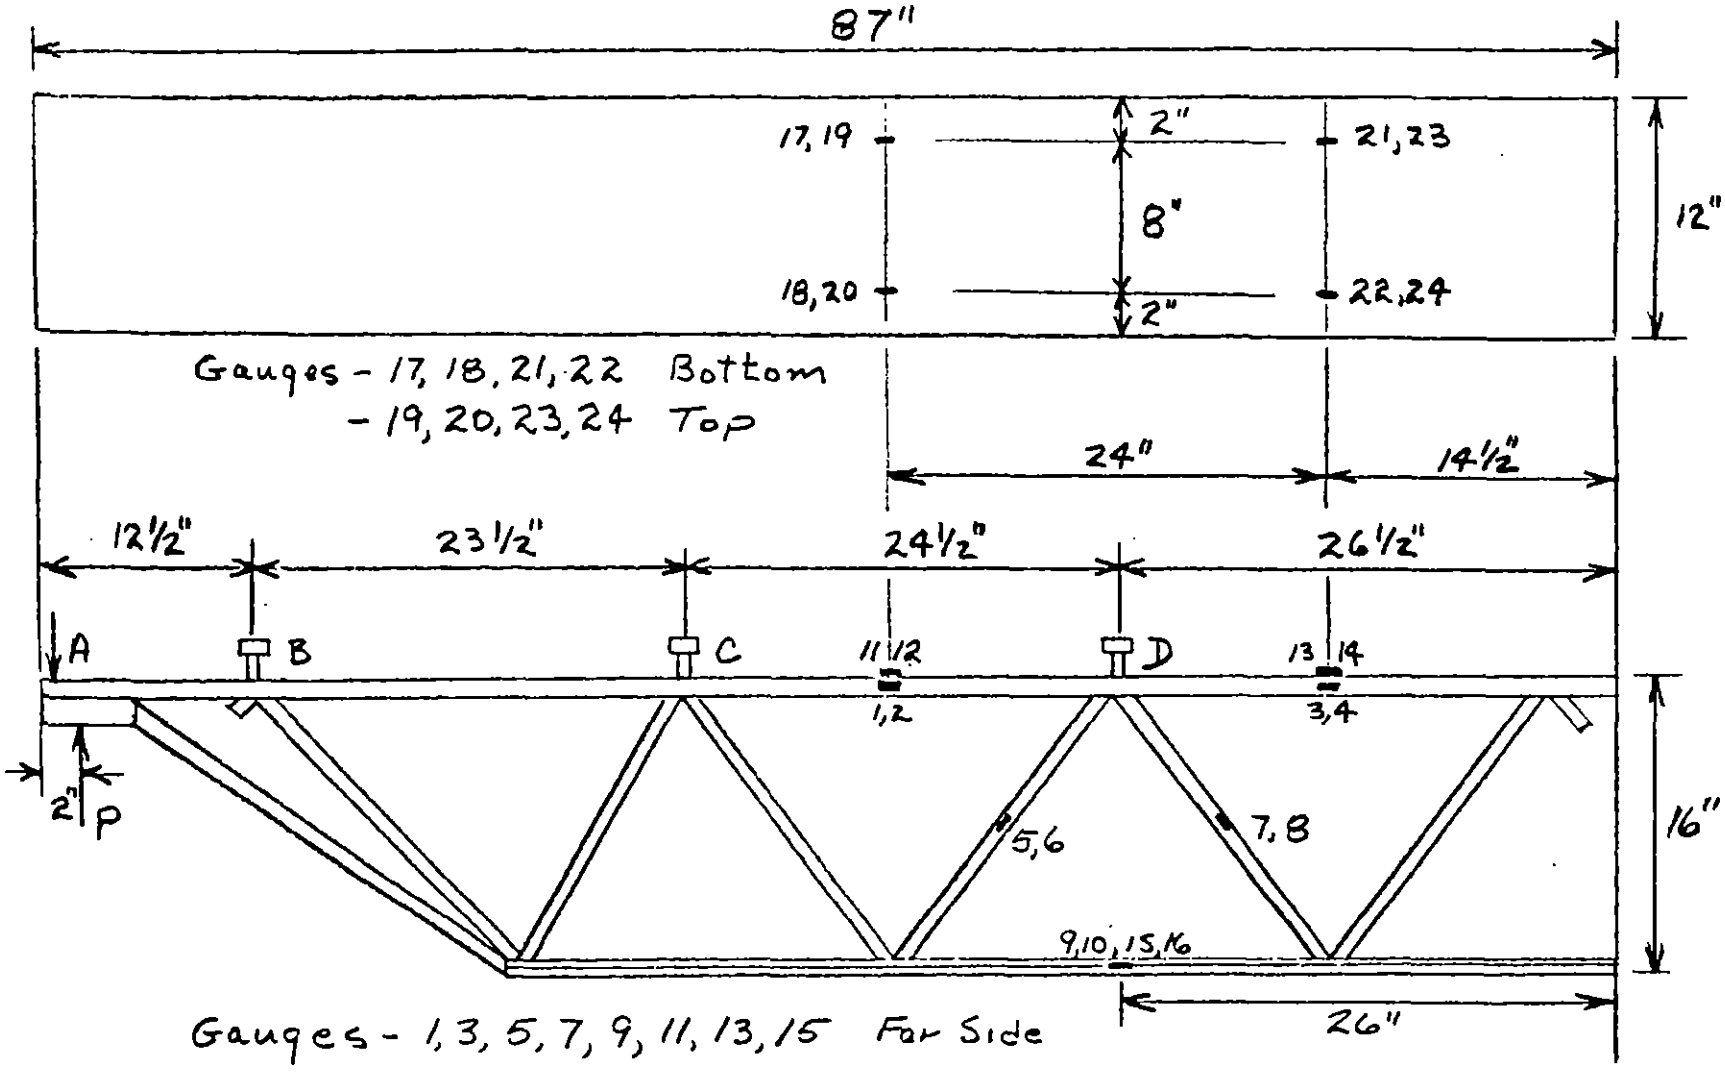
FIG 3 h - Test Joist C10

4.1.8 C10 - The load was applied in increments until considerable separation was noted between the compression chord and the slab. This occurred between the last shear connector and the support point of the cantilever. A tensile crack also appeared in the concrete at the first shear connector. Addition load increments resulted in the slab separation increasing considerably and the tensile crack extending almost to the top of the slab. The next load increments resulted in the buckling of the compression chord and the fracture of the shear connectors.

The failure of this cantilever was attributed to the buckling of the compression chord and then the fracture of the shear connectors.

C10 - buckling of the compression chord, fracture of the shear connectors.

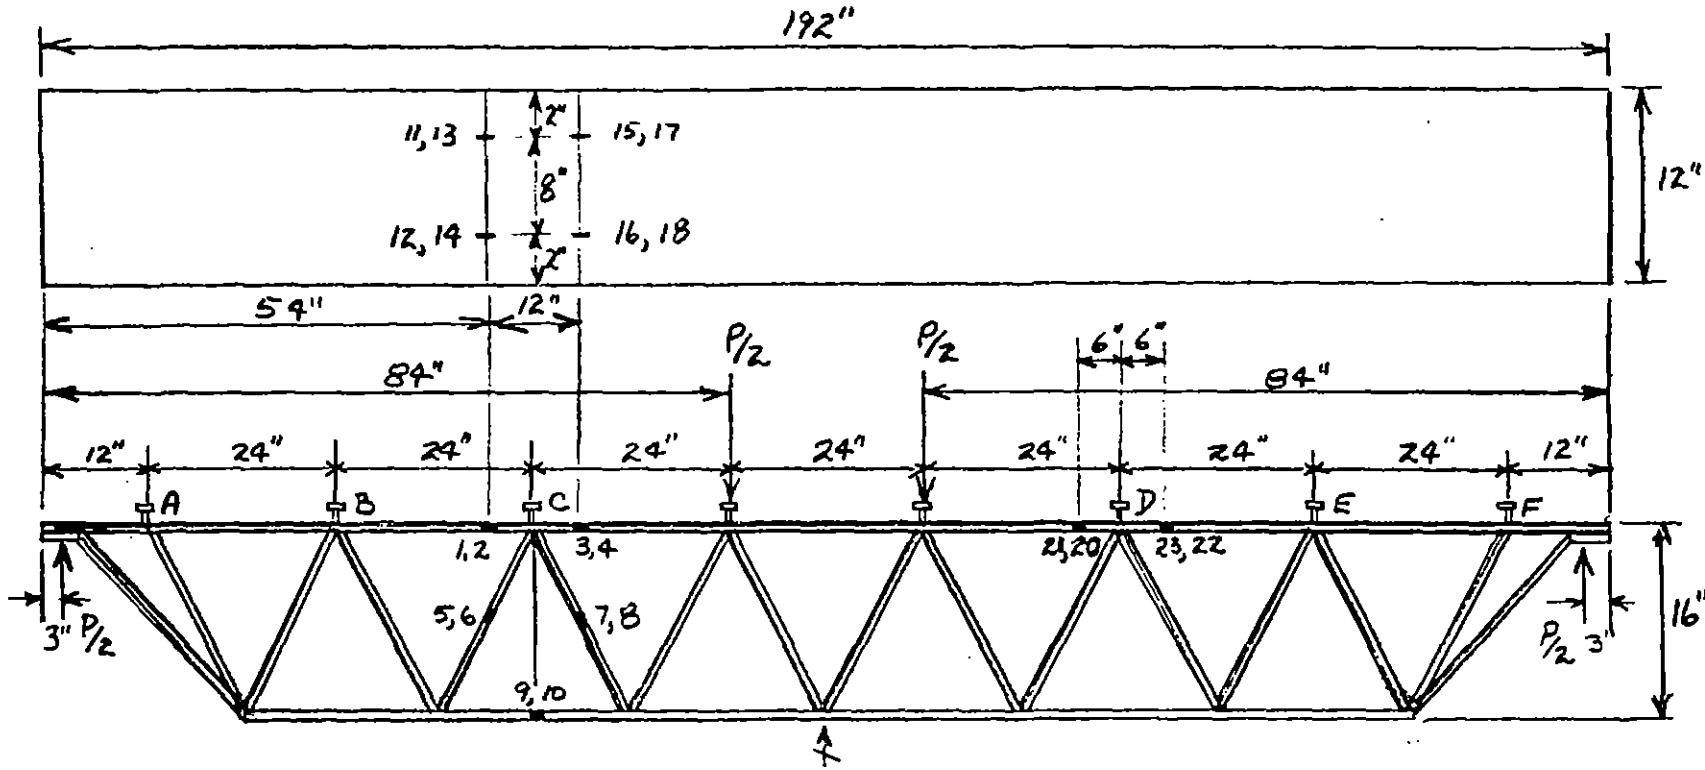
FIG 3 i Test Joist B1

4.2.1 B1 - The application of load was done in increments at which time readings and observations were made. The first cracks in the concrete slab occurred at the load points at a fairly high load. Increasing the load slightly caused a considerable separation of the slab from the compression chord in the vicinity of the second shear connector from the left. With additional load a loud report was heard and the left compression chord buckled laterally about one inch. The three shear connectors failed at the same time.

Failure was caused by the buckling of the compression chord followed by the fracture of the shear connectors.

B1 - buckling of the compression chord, fracture of the shear connectors.

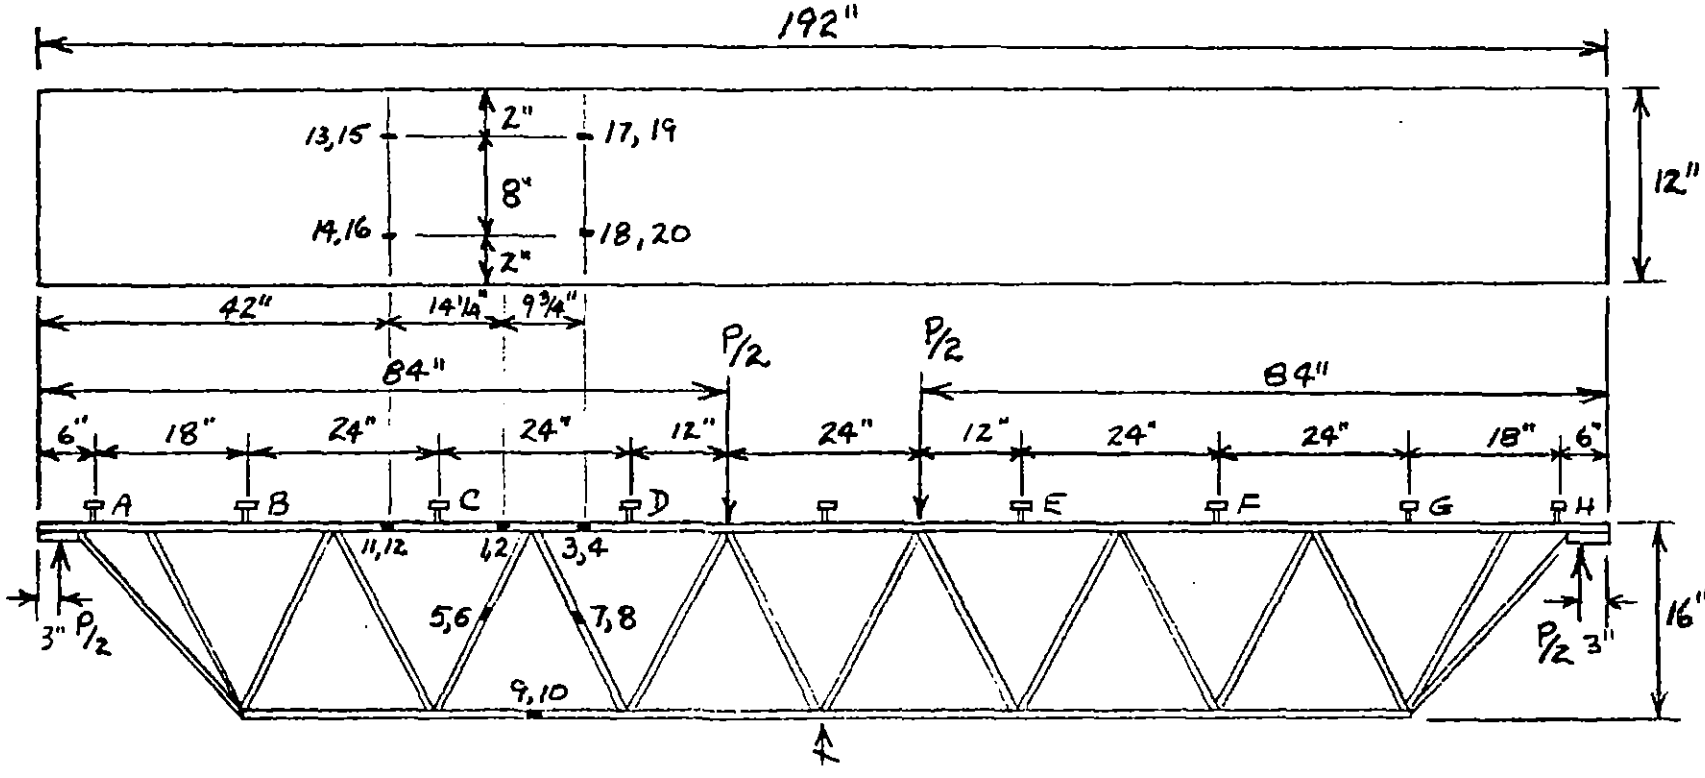
FIG 3j Test Joist B2

4.2.2 B2 - The load was applied in increments until nearly the maximum value was obtained before any cracks were observed. The cracks occurred in each span at the load points and at each shear connector closest to the load points. With the application of the next load increment a loud report was heard. Examination of the beam indicated considerable separation at the last shear connector in the right span. On attempting to increase the load the compression chord at this last shear, buckled vertically.

The failure was due to the compression chord buckling followed by the fracture of the shear connector.

B2 - buckling of the compression chord, fracture of the shear connectors.

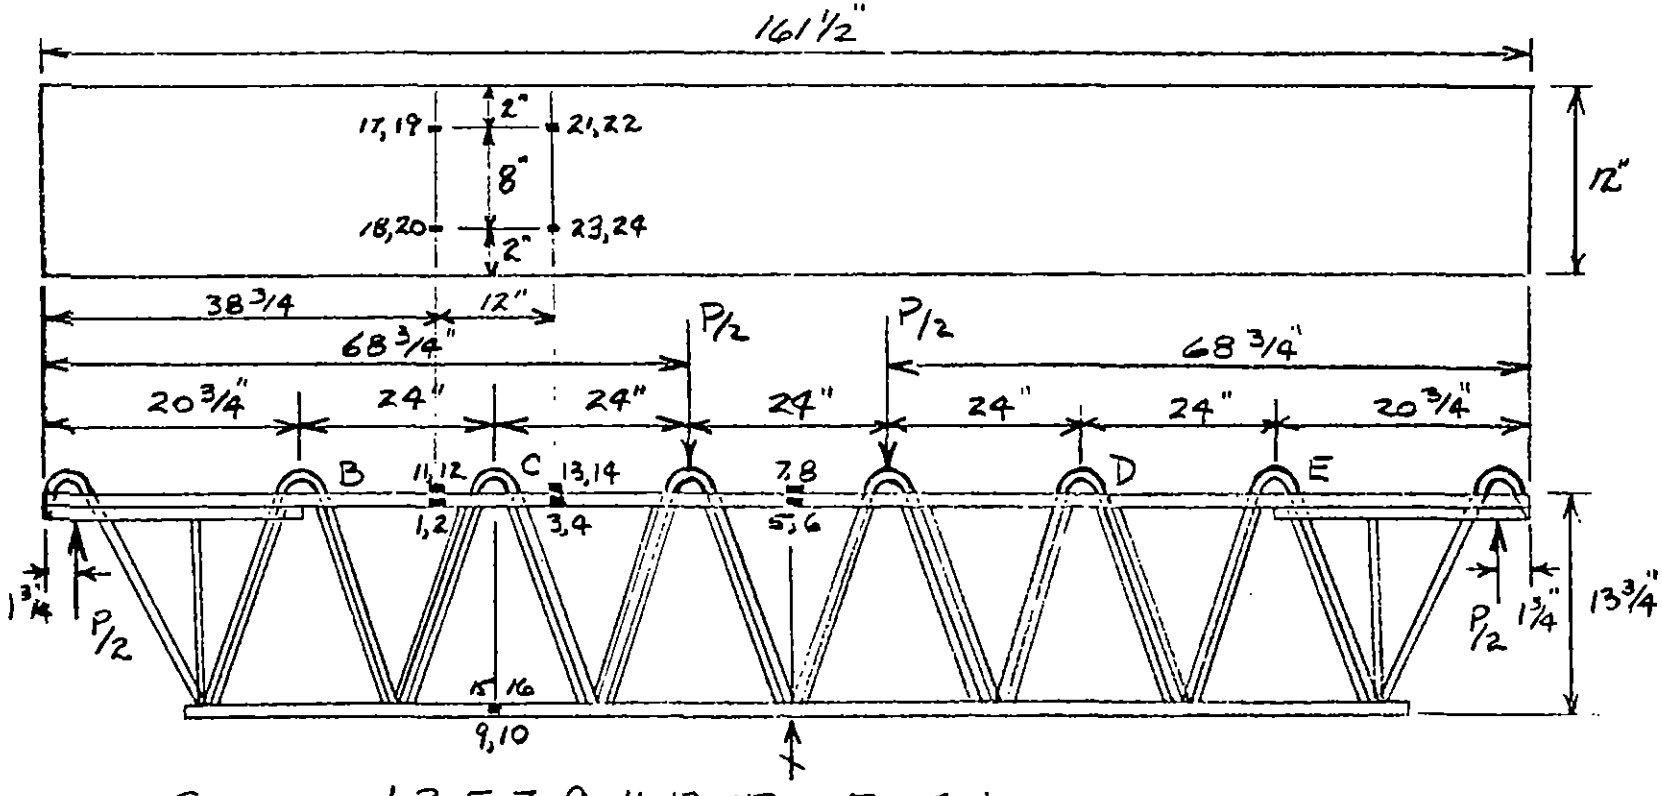
FIG 3 k Test Joist B3

4.2.3 B3 - The load was applied in increments until half way to the maximum load before a slight separation of the compression chord and slab occurred. Additional loading increased the amount of separation until, at

the second extended web in the right span, cracks appeared in the concrete. At this time cracks also appeared around the third extended web of the right span. As the load was again increased the cracks around the second and third extended webs developed into general crushing of the concrete and finally with a loud report the compression chord at the third connector began to buckle. The extended webs then pulled out of the concrete.

The failure was attributed to the crushing of the concrete around the extended webs followed by the buckling of the compression chord.

B3 - crushing of concrete, buckling of the compression chord.

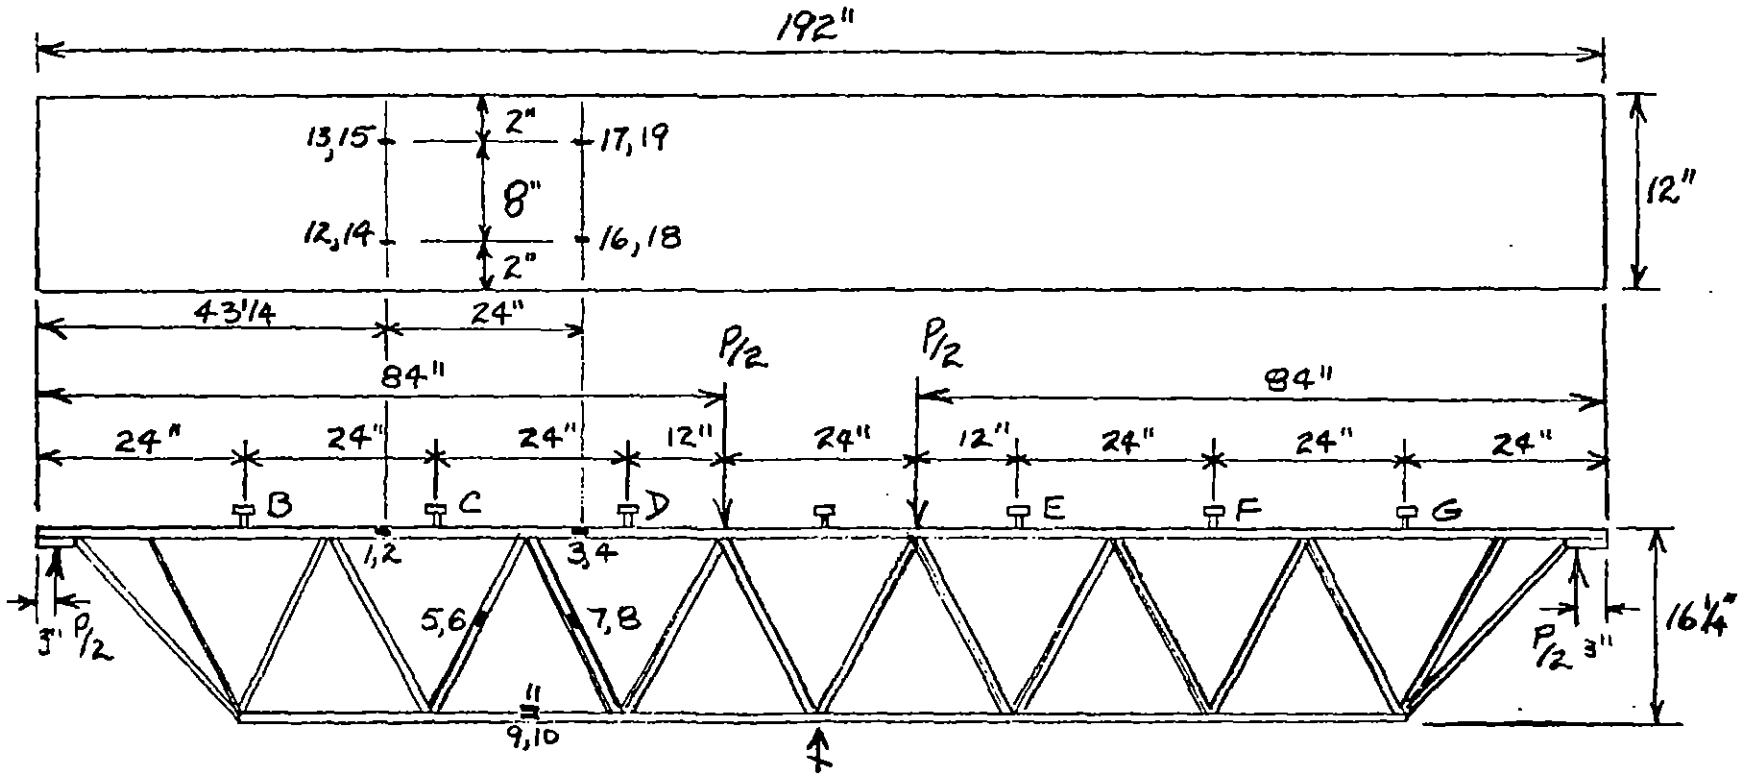
FIG 3 ℓ Test Joist B4

4.2.4 B4 - The first cracks appeared in the concrete at the location of the first shear connector in each span after only a small load. Additional load resulted in cracks at the second shear connector and load point of each span. When more load increments were applied it became difficult to hold the load steady and then the first compression web member in the left span buckled.

The failure was caused by the buckling of the first compression web member in the left span.

B4 - buckling of first compression web member.
